PORSF
11-3.15.1-3

Summary Report
for an Environmental Site Assessment and
Remediation of Property Located at
4959 NW Front Avenue, Portland, OR
prepared for
Northwest Airgas, Inc.

The Crawford Street Corporation (CSC) site is located on approximately 15 acres of land in an industrial area of the St. John's district of northern Portland (Bridgewater 2000, 2002a; DEQ 1999). The site includes the current addresses of 8424 and 8524 North Crawford Street. It is bordered by North Crawford Street to the north, North Burlington Avenue to the west, North Richmond Street to the east, and the Willamette River to the south (CFMW 1999, pers. comm.; Bridgewater 2002a). A heavy equipment/truck repair company is located across Crawford Street to the north of the site (CFMW 1999, pers. comm.). A residence, auto repair shop, and vacant property are located to the east of the site across North Richmond Street (Bridgewater 2000). The City of Portland Bureau of Environmental Services (BES) laboratory (ECSI #2452) is located across North Burlington Avenue, southwest of the site, and the western parcel of the Willamette Cove site (ECSI #2066) is located across North Richmond Street to the east (Figure

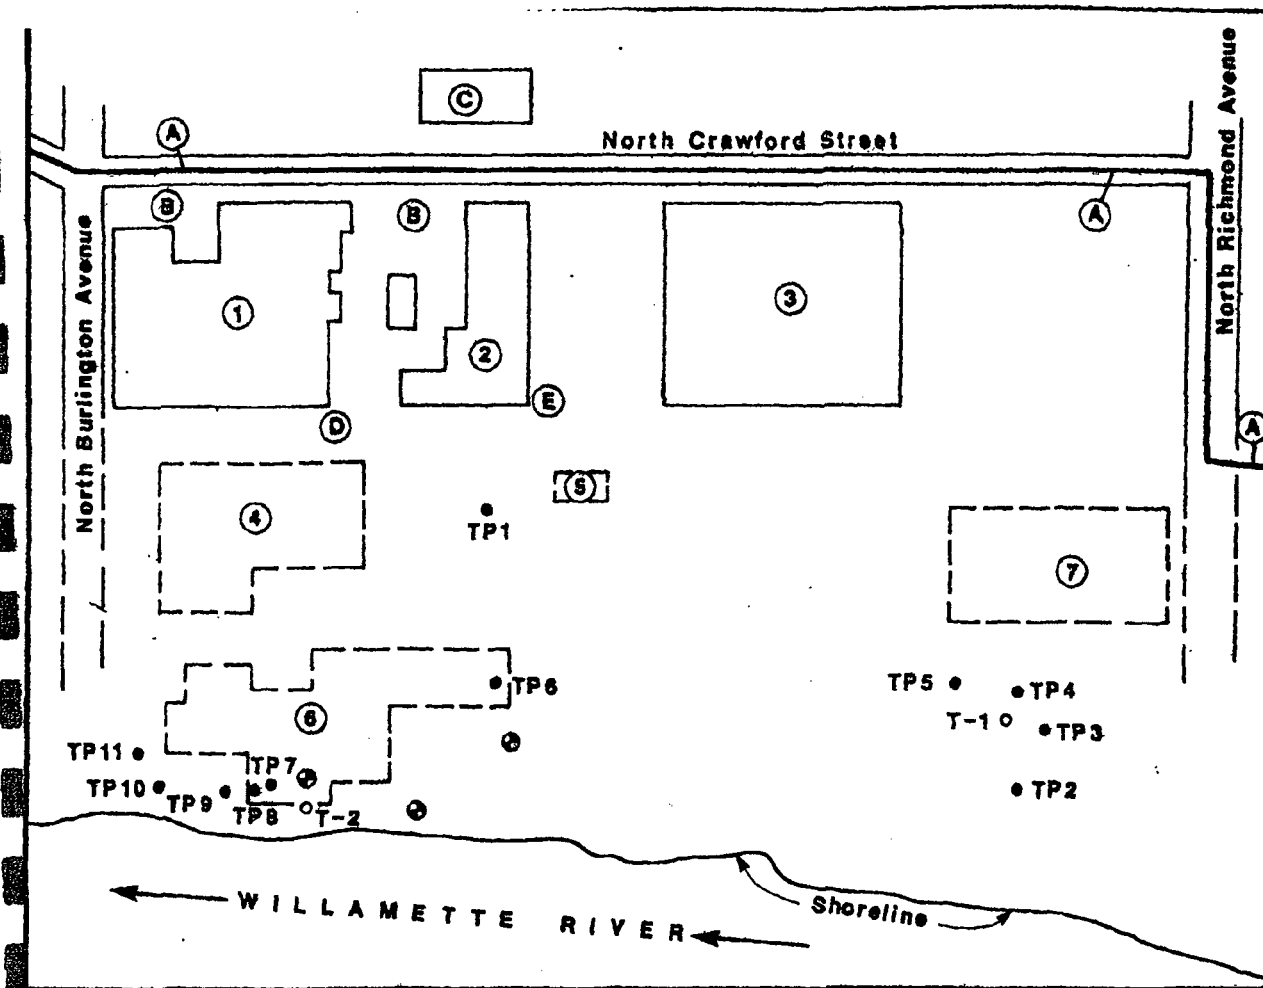
Figure 3. Historical Site Features (SE/E 1988)

A composite sample of three surface soil samples from an area of the black sand fill material was collected in November 1987, and submitted for EP Toxicity analysis [see Supplemental Figure 3 from SE/E (1988)]. None of the results reportedly exceeded maximum allowable levels (SE/E 1988).

Test pits [#6, 7, 8, 9, 10, and 11 in Supplemental Figure 3 from SE/E (1988)] were dug in the black sand fill in 1987 to determine the thickness of the fill deposit and whether residual oil saturation in the sand was present. Two soil samples were collected, one of which appeared oily (SE/E 1988). The samples were analyzed for various analytes including weight-percent oil and grease, total halogenated organics (TOX), VOCs, PCBs, and EP Toxicity metals. Oil and grease (400 mg/kg), TOX (294 mg/kg), xylene (0.31 mg/kg), and barium (0.31 mg/L) were detected (SE/E 1988).

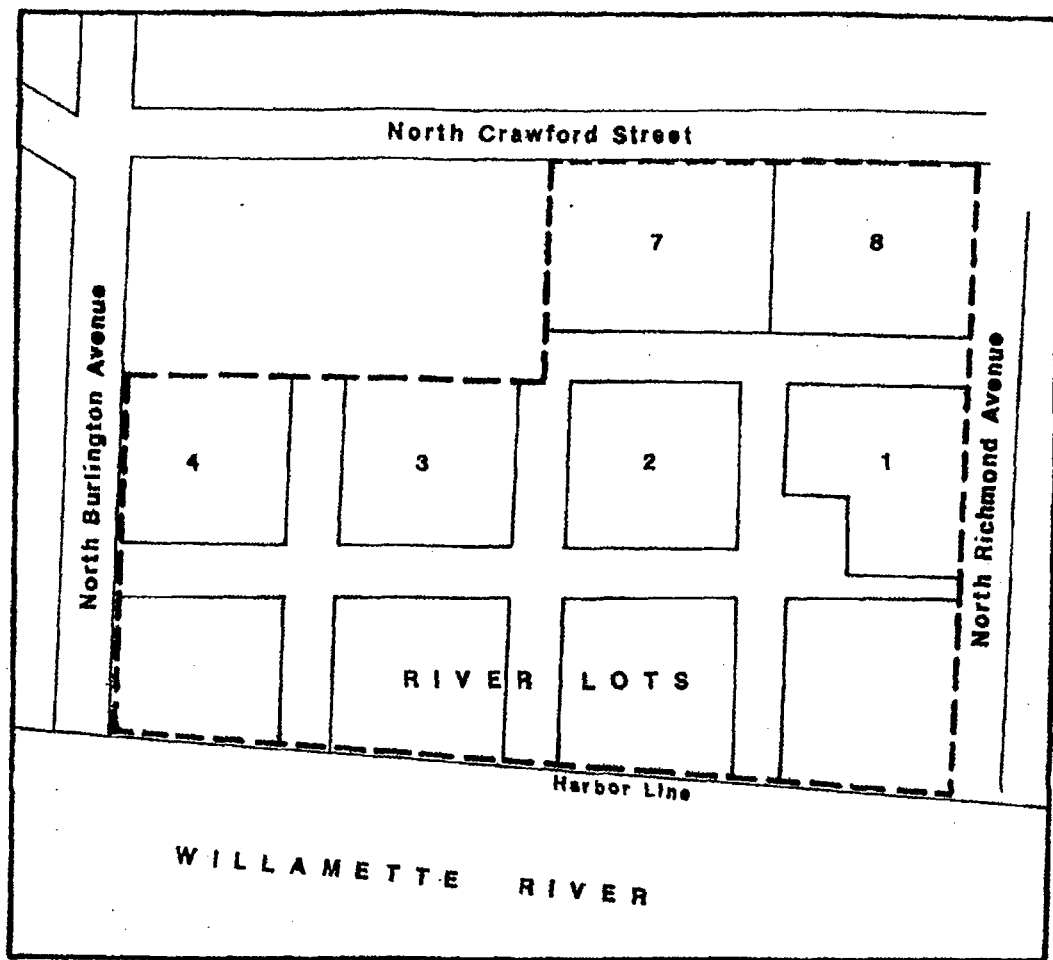
Table 3 and Figure 2. Historical Property Ownership (SE/E 1988)

SE/E (1988) also identified former Portland Steel Shipbuilding and Portland Stove and Range Manufacturing Co. usage of the northeastern parcel at the site. Past uses and locations of portions of the site are listed in Table 3 and Supplemental Figure 2 from SE/E (1988).

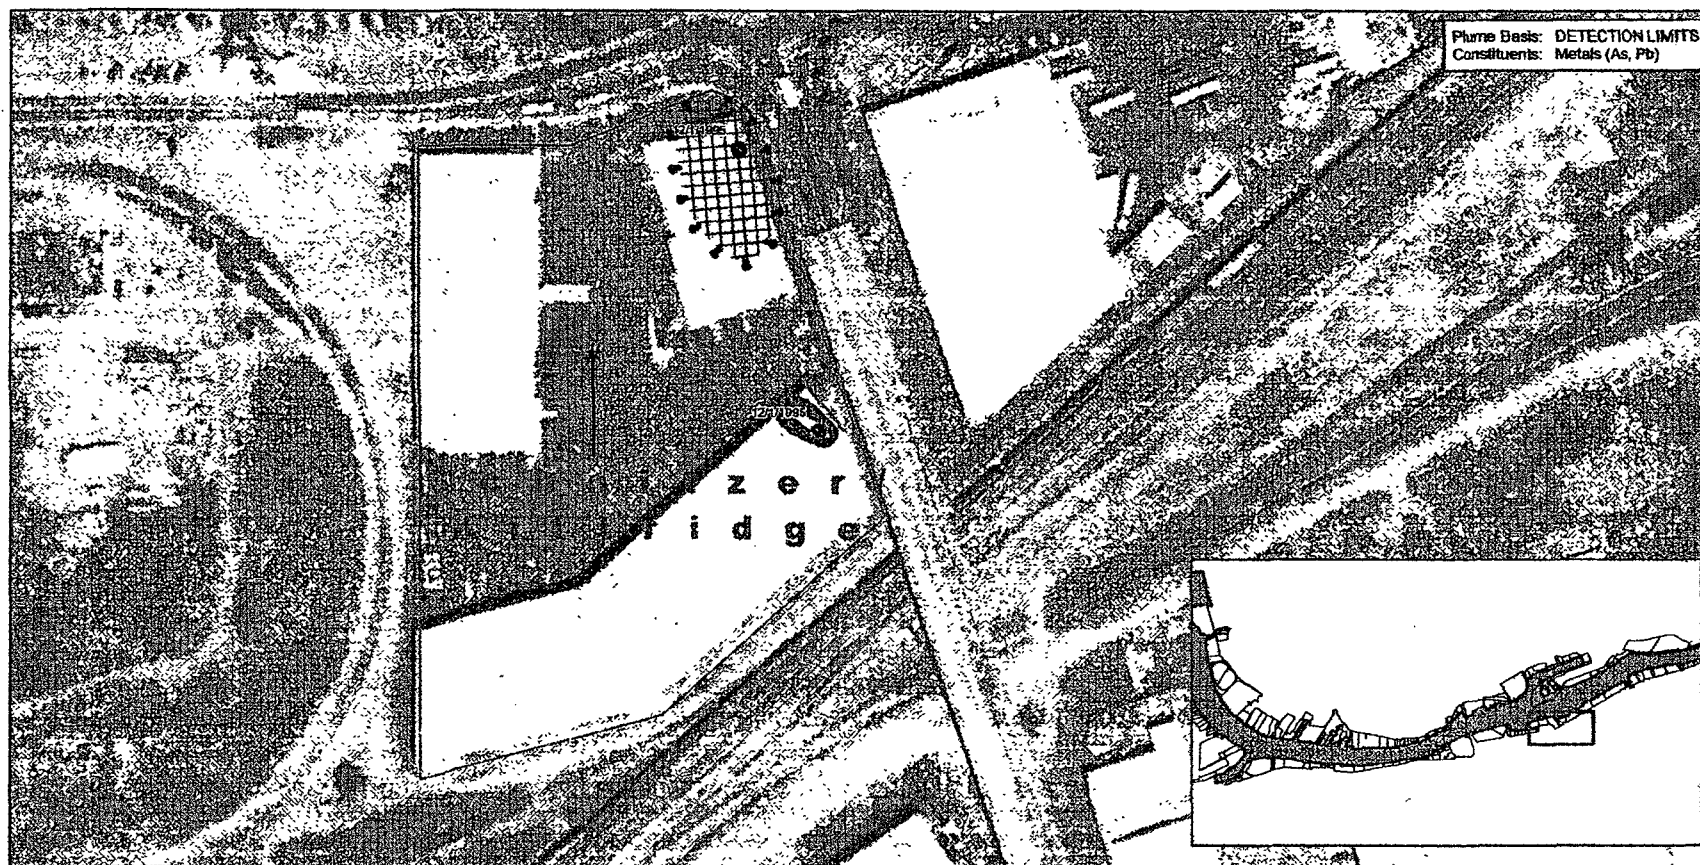
Figure 2
Portland Harbor RI/FS
Schmitz/Kitbridge
Upland Groundwater Quality Overview

Plume Basis: DETECTION LIMITS
Constituents: Metals (As, Pb)

Arsenic was detected in groundwater samples collected from three probe borings located in the northeast portion of the site. Lead was detected in a groundwater sample collected from the probe boring located along the east-central boundary of the site. Nickel was detected in groundwater samples collected from eight probe borings located throughout the site but at concentrations below applicable regulatory levels. Figure 2 shows the estimated extent of arsenic and lead in groundwater.

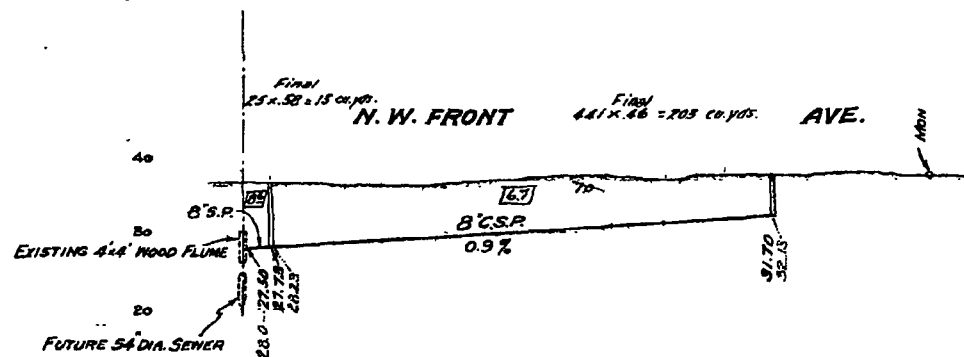
SEWER IN
N.W. FRONT AVENUE
 PORTLAND ORE. OCT. 1942
